### FRC ON-SITE AIR BAG DEPLOYMENT INVESTIGATION

CASE NO. 90-7

FLEET - 1990 ACURA LEGEND

LOCATION - NY

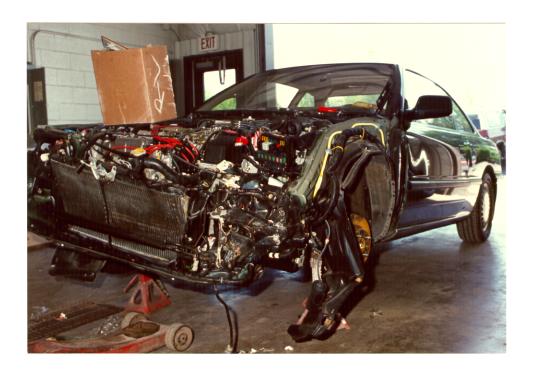
Left Front Three-Quarter View Of The Acura.

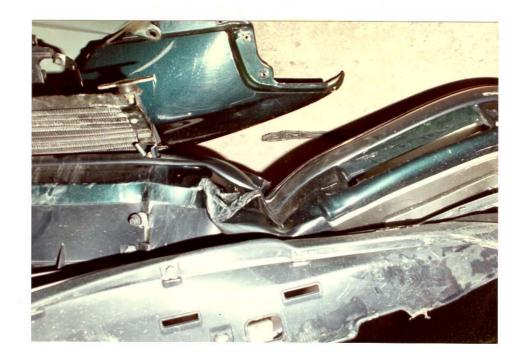
Damaged components included the front bumper, grille area, left headlight assembly, hood, radiator support panel, left front fender, and the structural components of the unibody system. The sunroof (fixed unit) glass was cracked at the left upper corner from the vehicle's absorption of the impact forces.

Front Bumper Crush.

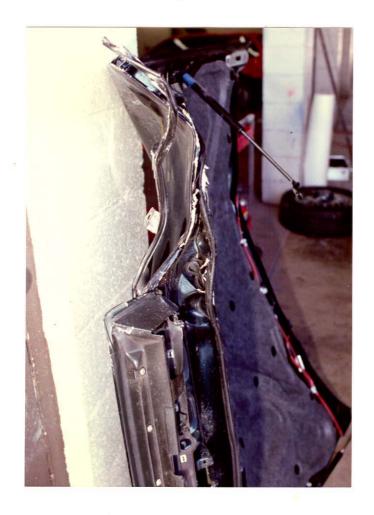
Hood Face Crush.

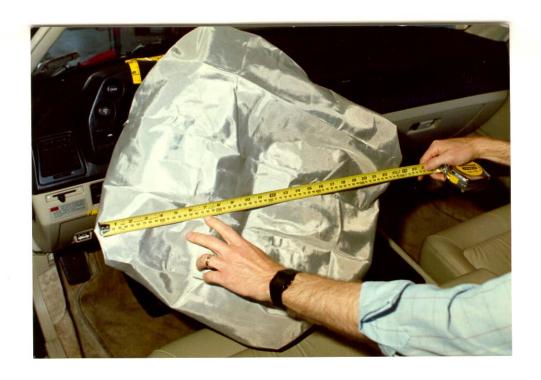
The Acura Legend was equipped with a driver air bag system that deployed at impact. The air bag measured approximately 24" in diameter (deflated state) and was not equipped with an internal tether. The bag was vented through two ports that were 1.25" in diameter located on the inboard edge of the bag (near the inflator) at the 5 and 7 o'clock positions. There was no generant residue deposits in the vicinity of the venting ports. The driver stated that he noted a foul odor within the vehicle immediately following the crash; however, he did not notice smoke or dust within the vehicle.

Deployed Air Bag And Driver Contact Points.

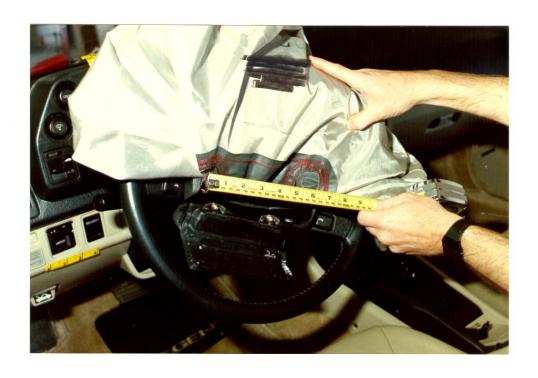
Air Bag Venting Ports.

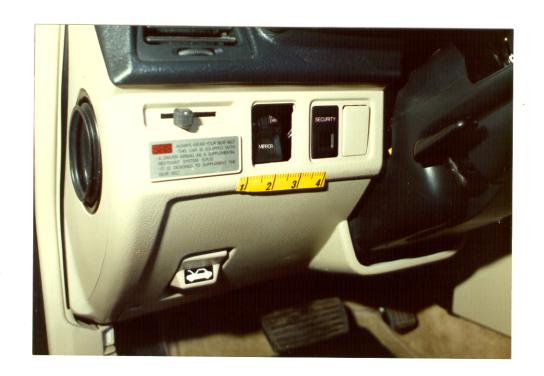
The driver's left knee impacted the mid instrument panel which displaced the outside rear view mirror switch from the mid panel. His left hand impacted and scuffed the upper instrument panel 17.5" left of center. The driver loaded the deployed air bag and the active belt webbing; however, these components were not damaged and did not

Driver's Left Knee Contact To The Mirror Switch.
